CENTRAL INTELLIGENCE AGENCY REPORT NO. [REDACTED]

COUNTRY Czechoslovakia

SUBJECT Uranium Mining in the Jachymov
Area 25X1A

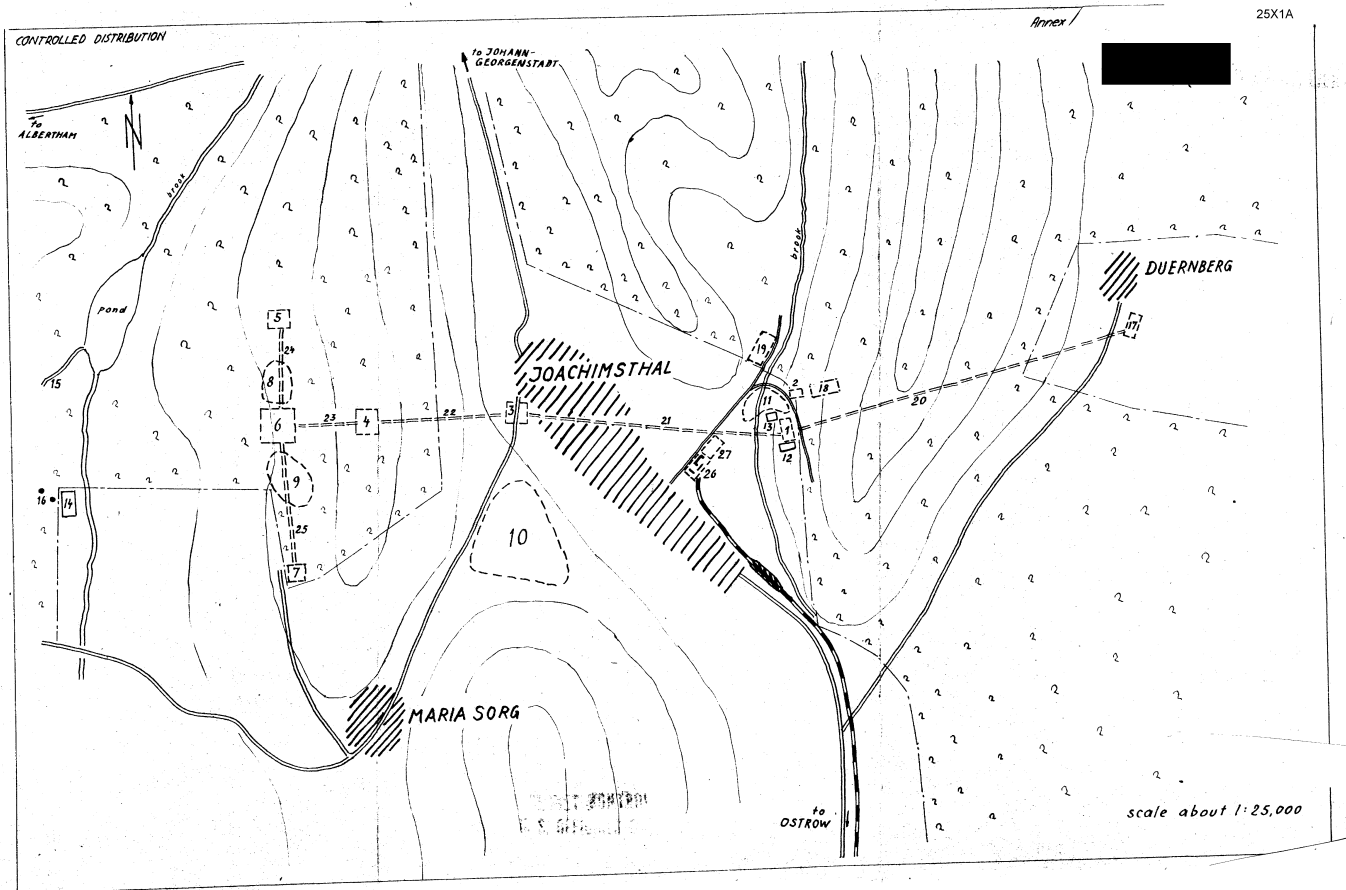
1 Annex: Sketch of the Joachimsthal Uranium Mining District.

- 1 Bruederlichkeit Mine
- 2 Traum Gottes Mine
- 3 Einigkeit Mine
- 4 Werner Mine
- 5 Edward Mine
- 6 Elias and Irene Mine
- 7 Werlsgruen Mine

- 8,9,10,11 Uranium ore waste dumps
- 12 Bruederlichkeit Washing Plant I
- 13 Bruederlichkeit Washing Plant II
- 14 Elias Washing Plant
- 15 Water ditch
- 16 Derricks
- 17 Duernberg Mine
- 18,19 Deforested area for building site of projected washing plant
- 20 Duernberg - Bruederlichkeit connecting gallery
- 21 Bruederlichkeit - Einigkeit connecting gallery
- 22 Einigkeit - Werner connecting gallery
- 23 Werner - Elias - Irene connecting gallery
- 24 Elias and Irene - Edward connecting gallery
- 25 Elias and Irene - Werlsgruen connecting gallery
- 26 Former tobacco plant
- 27 Cantonment
